TASHIKA CO., LTD.

Oxygen Sensor for Tin Bath

***On-line Measurement in the
Tin Bath of Furnaces***

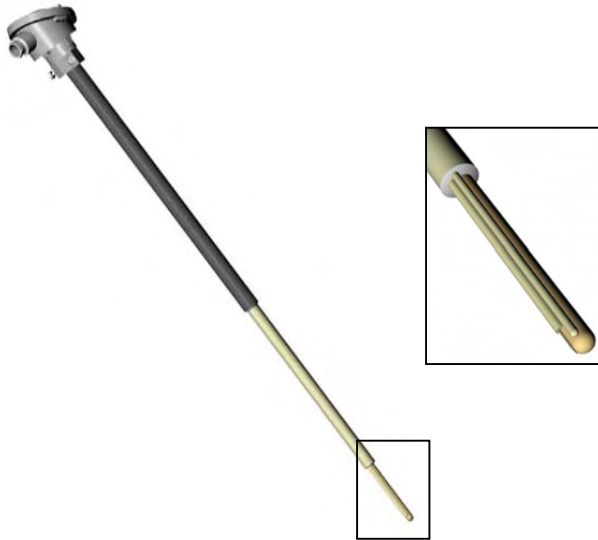
sensor head
stainless steel protection tube
alumina housing tube
ceramic measuring tip

Only the measuring tip is immersed in the tin bath. The measuring tip is free of cement connections. This construction increases lifetime and stability considerably in the aggressive molten tin. An indicative lifetime is about 4 to 6 months at 750 °C.

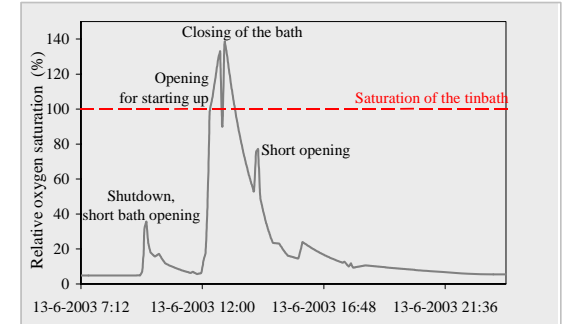
During bath openings a large quantity of air enters the float tank, which immediately results in a steep increase of the oxygen level of the tin bath. However, to prevent surface defects, it is important to avoid high oxygen levels during and after a bath opening. After closing of the bath, the sensor signal may help the operator to adjust the hydrogen level in the forming gas in order to return in a controlled way to the regular oxygen level.

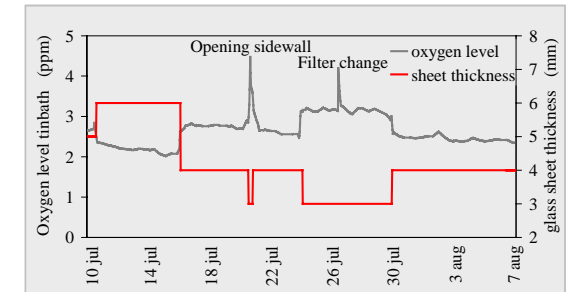
A glass sheet thickness decrease causes an increase in the oxygen level of the tin bath. During the production of a thinner sheet more surface area of glass passes through the float tank. This results in more oxygen diffusion from the sheet to the tin bath.

Maintenance actions such as a filter change and a short side wall opening are clearly visible as distinct peaks in the sensor signal.
